**PRELIMINARY ASSESSMENT/  
VISUAL SITE INSPECTION**

**MANNER PLATING, INC.  
LOVES PARK, ILLINOIS**

**ILD 082 050 576**

**FINAL REPORT**

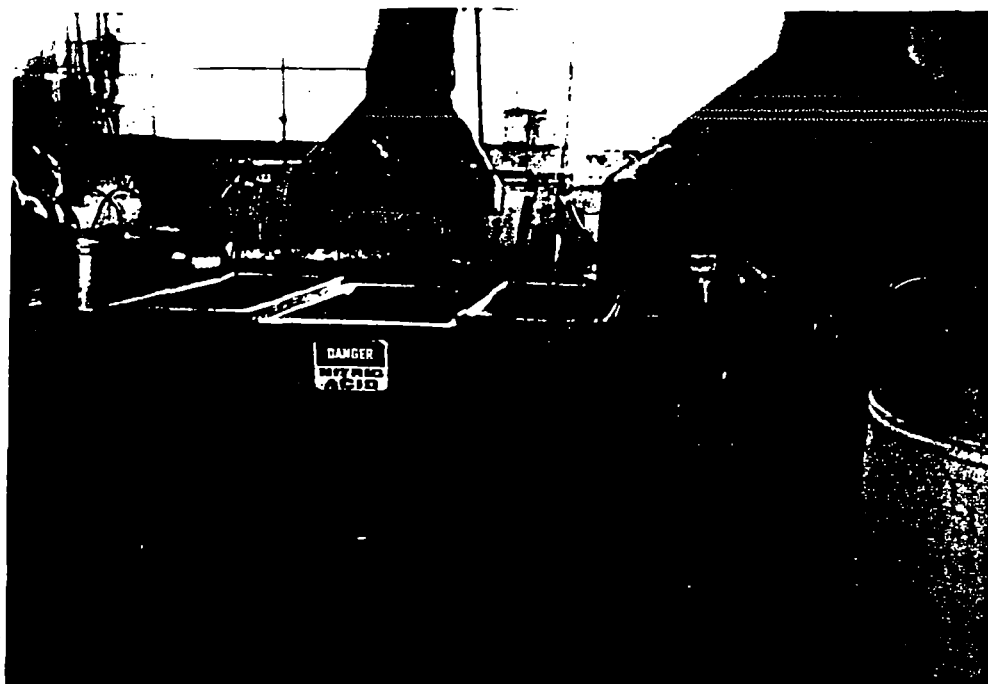
Photograph No. 1

Location: Passivating Line

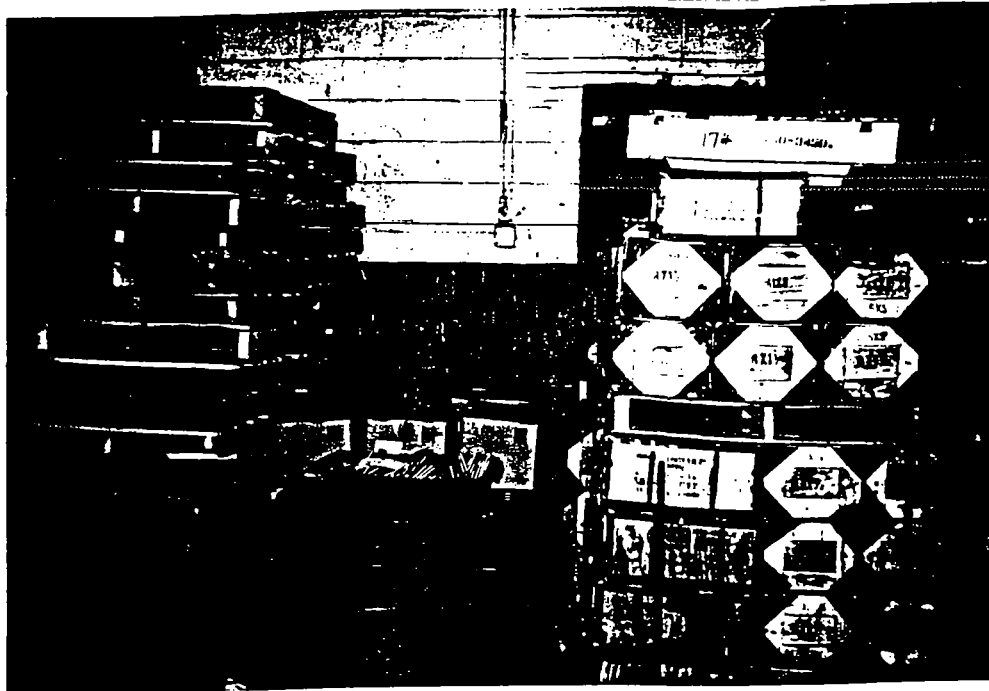
Photograph No. 3

This 30 foot by 5 foot former storage area was used to store hazardous waste sludge in 55-gallon drums from 1974 to 1984. However, the unit did not undergo formal RCRA closure until 1988. It is located in the central portion of the facility, south of the Automatic Zinc Plating System (see photo 3).

The area is currently used to store finished product. No visual evidence of a release was observed.

Location: SWMU 1

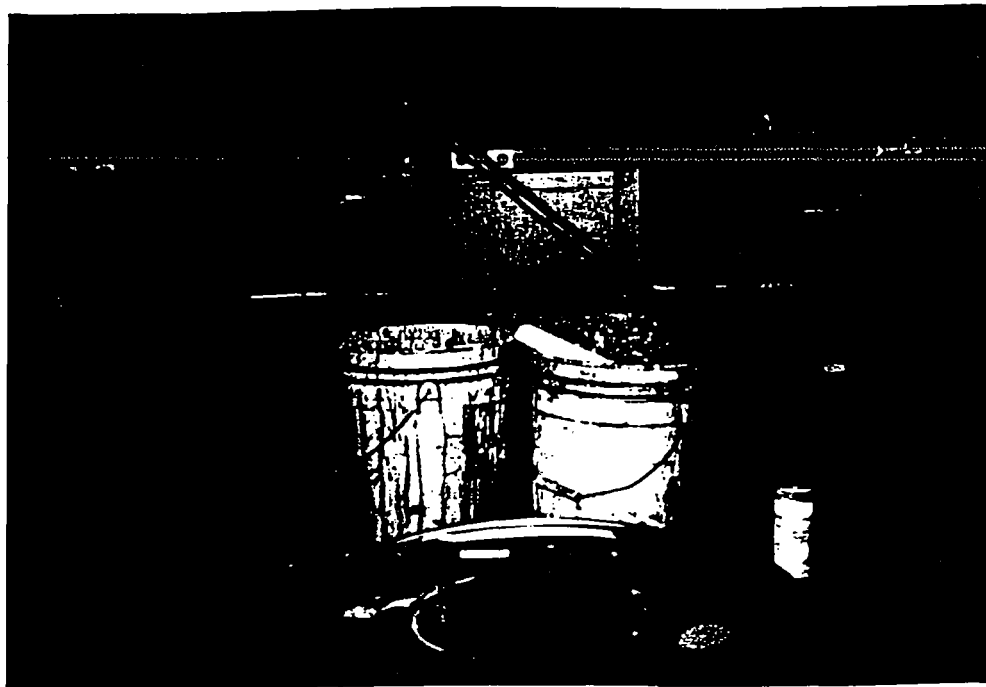
Photograph No. 5  
 Orientation: North  
 Description: Automatic Zinc Plating System.

Location: Plating Line  
 Date: 07/24/91

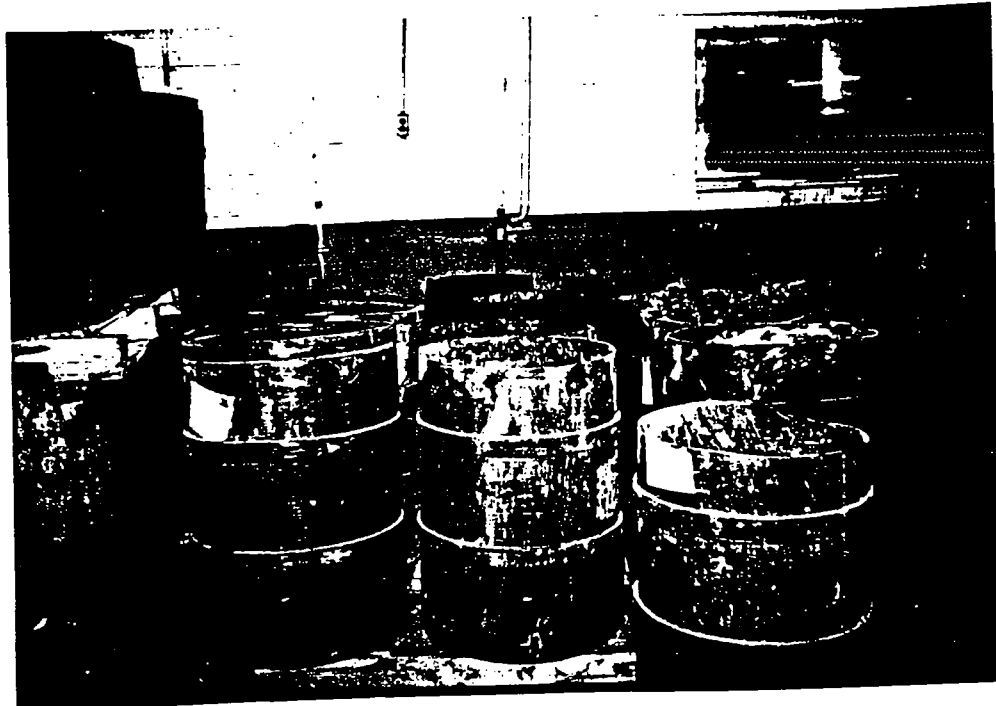
Photograph No. 9

Date of Startup:	1983
Date of Closure:	This unit is currently active.
Wastes Managed:	Non-hazardous caustic ash, spent hydrochloric acid, spent nitric acid, zinc, chromate (D007).
Release Controls:	All of these units are on sound 8-inch thick concrete flooring. The Wastewater Treatment Unit has a 2,500-gallon clarifying overflow tank that is used as secondary containment in the event of a release from the other tanks.
History of Release:	No releases were documented at this unit.
Observations:	At the time of the VSI, RAI observed a 55-gallon drum 1/2 full of plating cake, an 8-foot by 4-foot sheet of plywood with plating cake placed upon it awaiting transfer to the Sludge Drier, and 13 55-gallon plastic drums containing waste from the caustic tanks. The waste from the caustic ash (non-hazardous) tanks has been at the facility since January 1991. The facility should provide documentation substantiating the classification of the caustic ash as non-hazardous.

Description: Waste generated from the caustic cleaning tanks. This waste has been accumulating since January 1991.

No further corrective action is recommended at this time. However, the facility should provide documentation substantiating classifying waste caustic ash as non-hazardous.
